STRENGTHENING OF FIRE DAMAGED RC COLUMN AT VARIOUS TEMPERATURE USING FERROCEMENT JACKETING

M.S.I. Shohag*¹, E.A. Nishat², S.Tabassum³, M. Fahad⁴ and D.M. Ali⁵

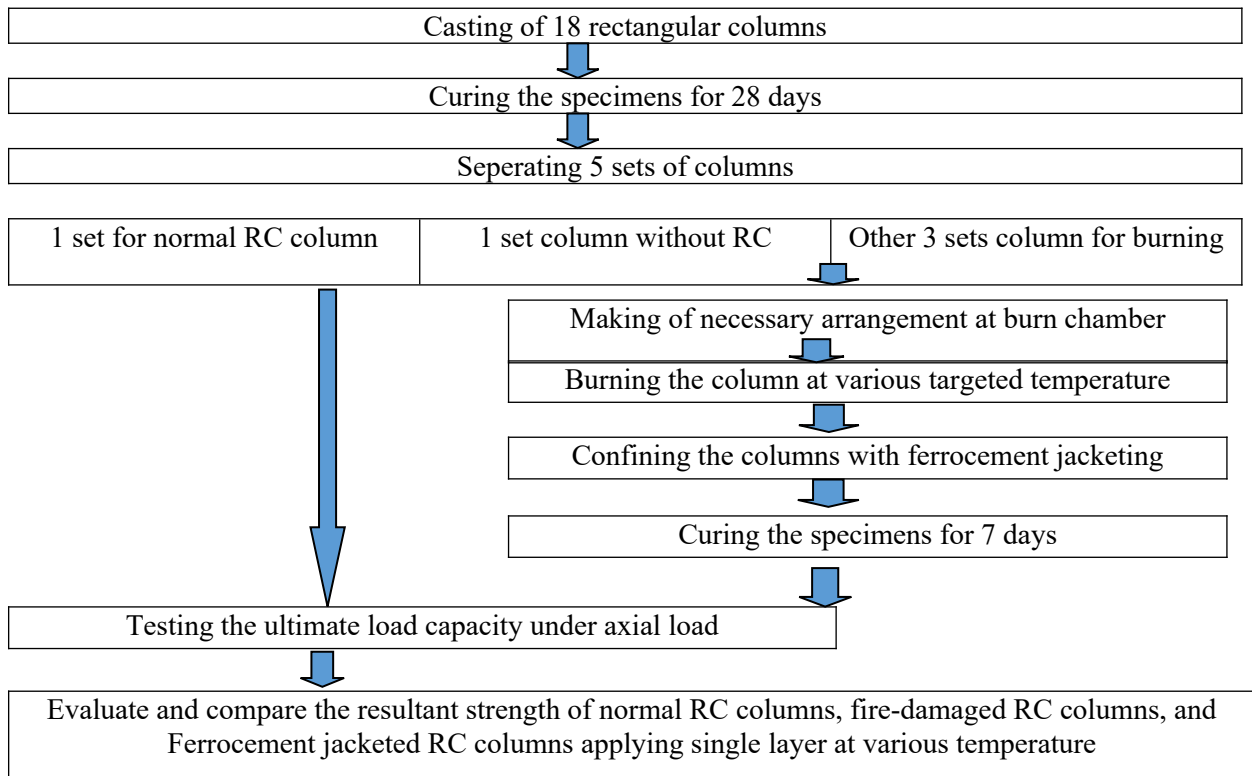
Experimental methodology is shown in the flow chart in the following:

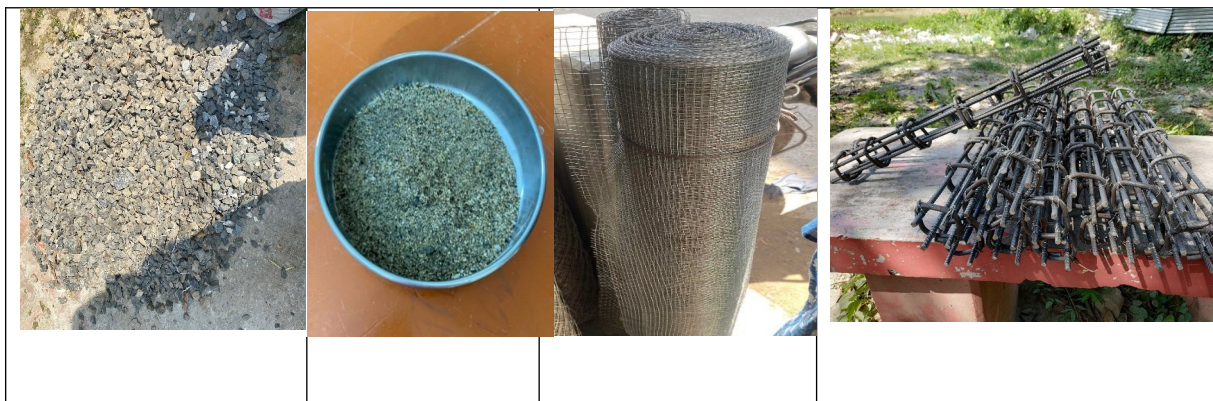
Step 1: The necessary components for casting columns, including coarse aggregate, sand, cement, water, admixture, and reinforcement, were gathered.

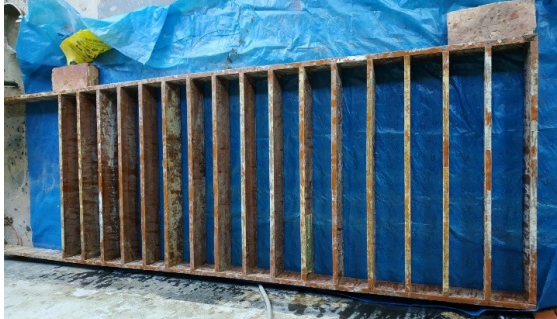
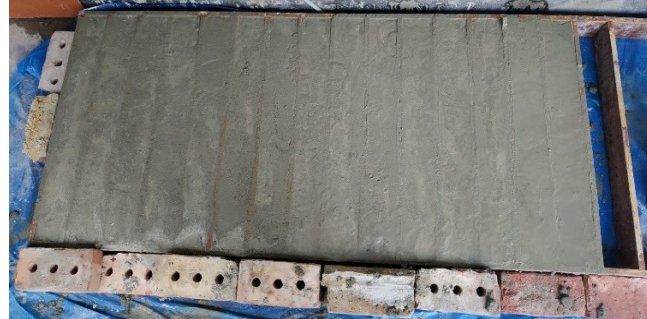
Step 2: A wooden formwork was constructed as shown in Figure.

Step 4: The columns are casted in the forma after the concrete has been mixed, and a vibrator is used to achieve optimum compaction as shown in Figure 3.6.

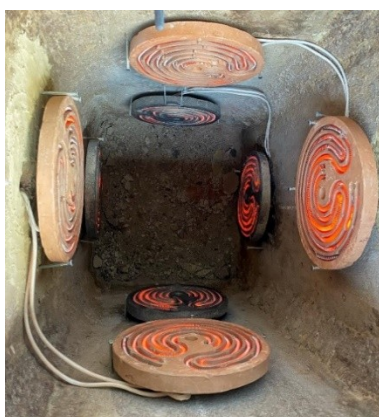
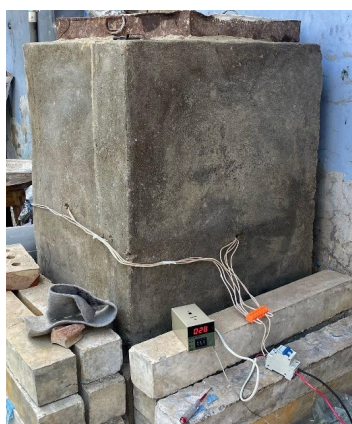
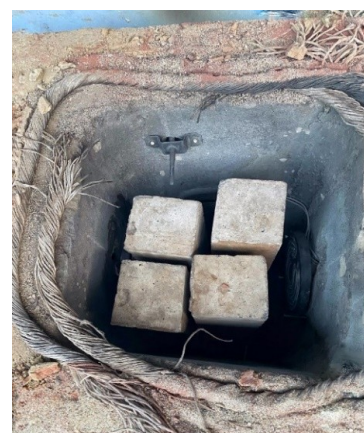
Figure: 3.1.1 Burning of column at burn chamber

After the burn chamber was tested and ready for burning the specimens, four of each set of column was put down into the chamber. Total of 3 sets of 12 rectangular columns were similarly put down. Considering the heat loss, first set of column was burnt at 350°C and it took one hour and fifteen minutes. Consequently, 2nd and 3rd sets of columns were burnt at 450°C and 600°C respectively and these sets of columns took two hours and ten minutes & three hours and forty-five minutes respectively. After reaching the targeted temperature, the heaters were switched off and cooled down to room temperature which took 12 to 14 hours as per average. The burnt columns were dispatched off the chamber once it came down to room temperature as shown in Figure 3.1.1 and figure 3.1.2

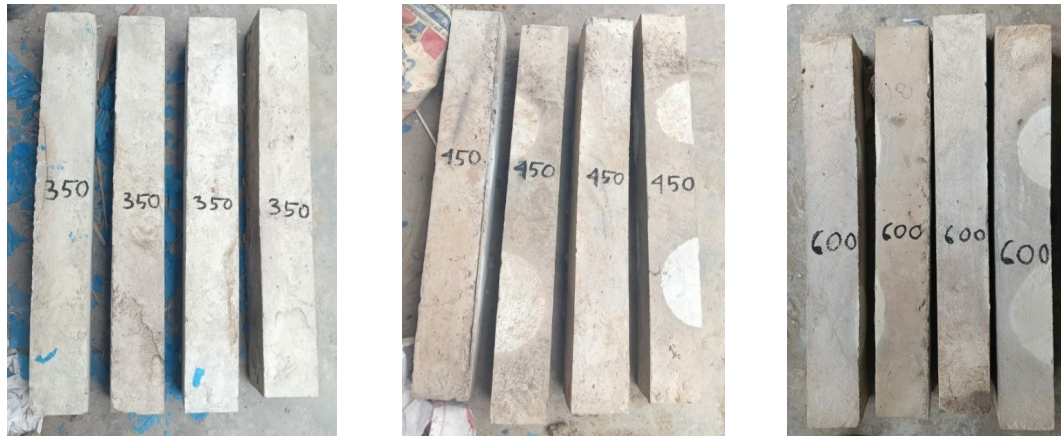
Figure 3.1 Columns after fire damage at 350, 450 & 600 degree centigrade respectively

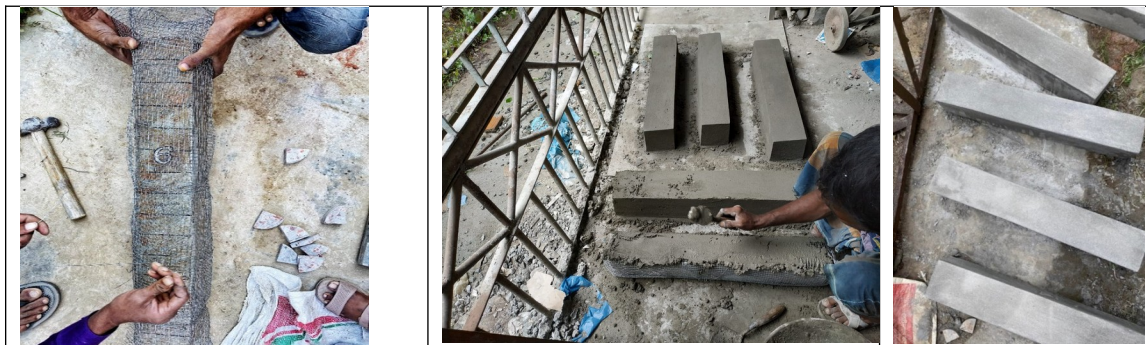
Ferrocement is a construction material simply consisted of 5% wire mesh and 95% cement mortar. The wire mesh used in this study had a diameter of 0.65 mm and center to center spacing 8 mm. Locally available MS wire mesh was used. A ratio of 1:2 of cement and sand was applied following a water cement ratio 0.4 as shown in Figure. Hand plastering was done to properly bind the new material with the existing material as shown in Figure. The jacketing was done in single layers as shown in Figure 3.1.3.

Figure 3.1.3 Columns after ferrocement jacketing with single layer.

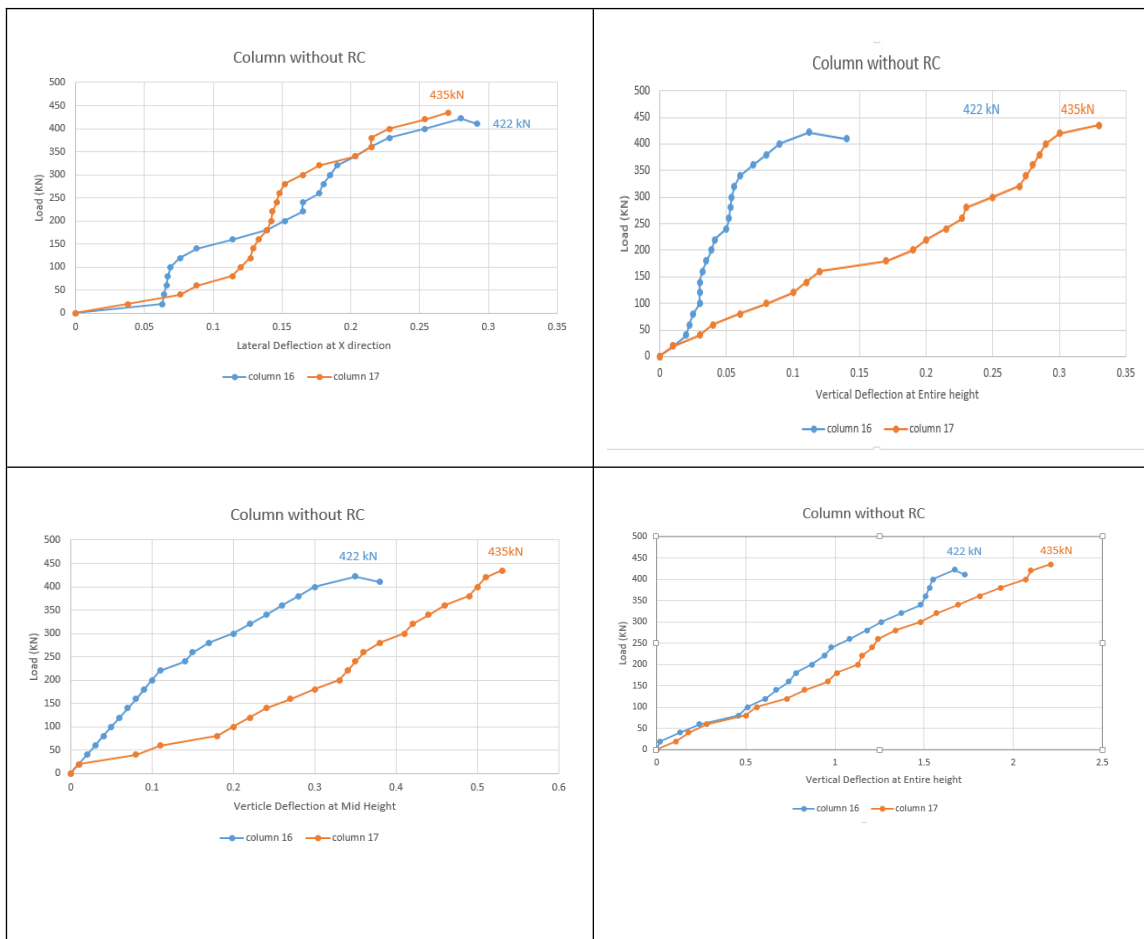
Figure 4.10 Applied Load with respect to Lateral X,Y, Vertical Deflection at mid & entire height
(Columns without Reinforcement)

Sl. No.	Specimen Name	Maximum Load(kN)	Lateral Deflection (X-direction) (mm)	Lateral Deflection (Y-direction) (mm)	Vertical Deflection (mm)	Vertical Deflection (Entire height) (mm)
1	Column 16	422	0.280	0.112	0.350	1.670
2	Column 17	435	0.271	0.330	0.530	2.210
3	Column 18	425	0.200	0.530	0.470	2.130

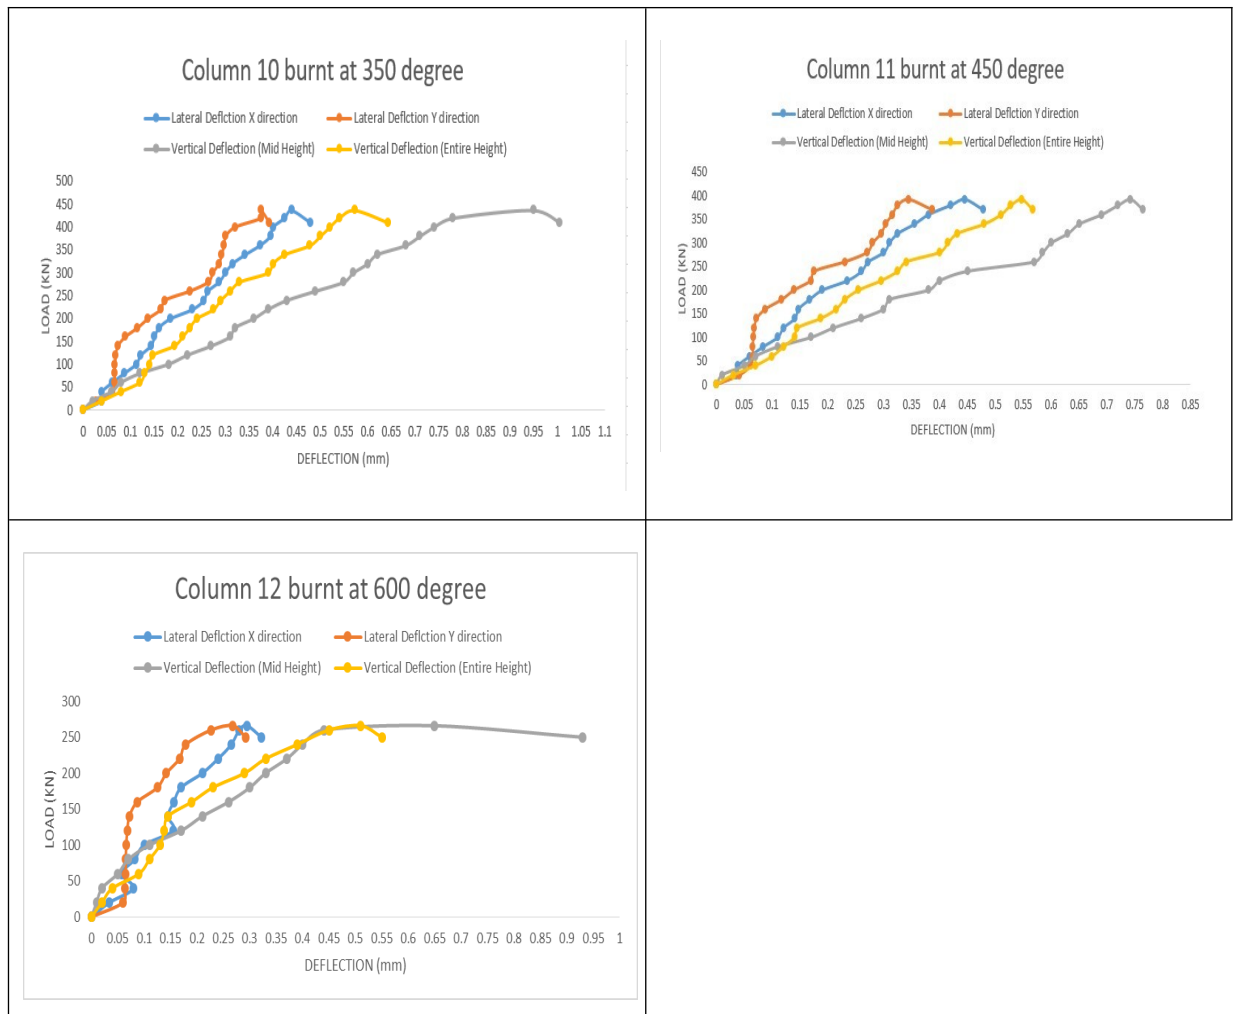
Figure 4.13: Applied Load with respect to four types of deflections (X,Y direction, Mid and Entire height) at 350, 450 & 600 degrees centigrade respectively

Sl. No.	Specimen Name	Maximum Load(kN)	Lateral Deflection (X direction) (mm)	Lateral Deflection (Y direction) (mm)	Vertical Deflection (mm)	Vertical Deflection (Entire height) (mm)
1	Column 10	437	0.45	0.64	1.87	0.46
2	Column 11	392	0.51	0.57	1.42	0.65

Sl. No.	Specimen Name	Maximum Load(kN)	Lateral Deflection (X-direction) (mm)	Lateral Deflection (Y-direction) (mm)	Vertical Deflection (mm)	Vertical Deflection (Entire height) (mm)
1	Column 1- a	487	0.73	0.45	0.46	1.76
2	Column 1- b	483	0.68	0.40	0.42	1.73
3	Column 1- c	490	0.90	0.50	0.48	1.85

Sl. No.	Specimen Name	Maximum Load(kN)	Lateral Deflection (X-direction) (mm)	Lateral Deflection (Y-direction) (mm)	Vertical Deflection (mm)	Vertical Deflection (Entire height) (mm)
1	Column 2- a	477	0.290	0.500	0.190	1.800
2	Column 2- b	474	0.270	0.498	0.160	1.770
3	Column 2- c	489	0.300	0.515	0.200	1.815

Sl. No.	Specimen Name	Maximum Load(kN)	Lateral Deflection (X-direction) (mm)	Lateral Deflection (Y-direction) (mm)	Vertical Deflection (mm)	Vertical Deflection (Entire height) (mm)
1	Column 3- a	417	0.64	0.43	1.19	6.37
2	Column 3- b	421	0.77	0.55	1.42	6.81

- ✓ Average normal strength of RC column is 502KN, the residual strength of fire damaged column after burning at 350, 450 and 600 degrees are 437KN, 392KN, 266KN.
- ✓ Normal strength of RC column is reduced by 13%, 22% and 47%, after burning at 350, 450 and 600 degrees respectively.
- ✓ Jacketing in single layer regained the lost strength by 79%, 76% and 65% for 350, 450 and 600 degrees respectively.
