MORPHOLOGICAL CHANGES AND BAR DYNAMICS OF THE JAMUNA RIVER: A STUDY OF THE JAMALPUR TO MANIKGANJ REACH

Keywords: Morphological Changes, Jamuna, Bars, Landsat

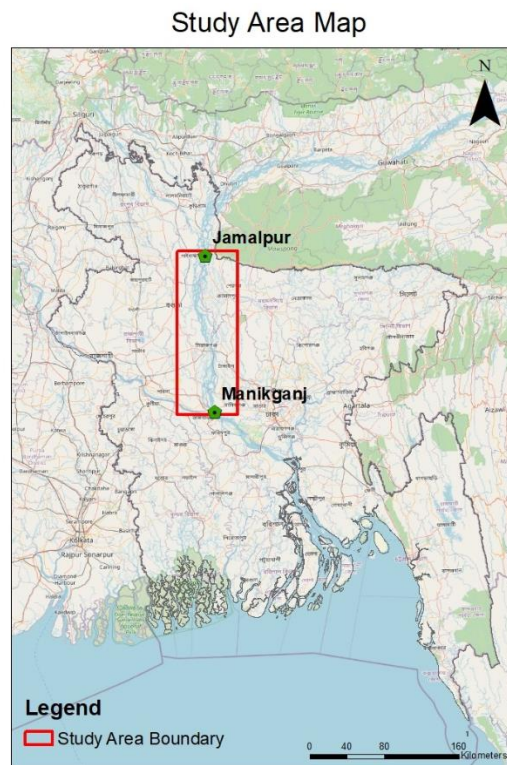
The study area of this study is the Jamuna River from Jamalpur to Manikganj districts in Bangladesh. This area covers about 210 km of the river course, from the confluence of the Jamuna and Padma rivers near Goalundo Ghat to the confluence of the Jamuna and Meghna rivers near Chandpur. The study area is bounded by the districts of Sirajganj, Pabna, Mymensingh, Tangail, and Dhaka on one side, and the districts of Kurigram, Rajshahi, and Khulna on the other side. The study area is shown in **Figure 1**.

Figure 1: Study area map of Jamuna River from Jamalpur to Manikganj districts in Bangladesh.

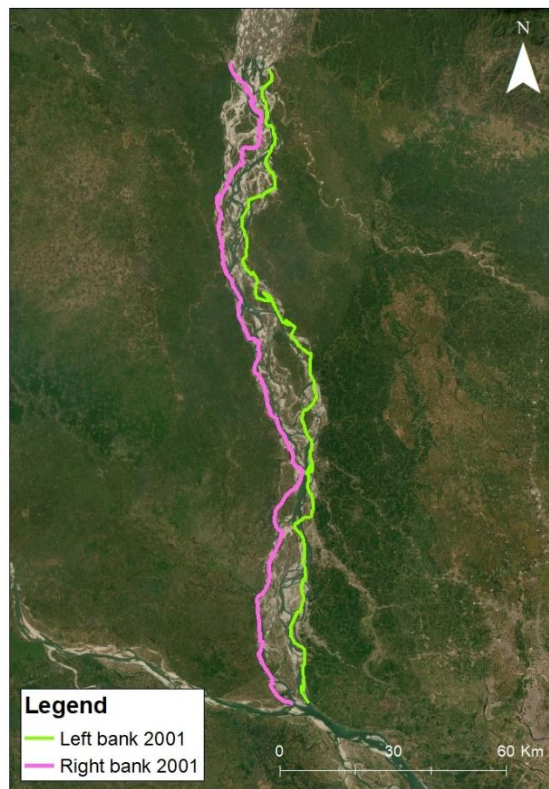
Banklines Digitized from Satellite Image of 2001

In this study, the river bank lines were manually traced as part of the digitization procedure. The banklines has been saved in the GIS program as a vector layer once it has been digitized. The patterns of erosion and accretion can then be studied, as well as the changes in the river bank over time, using this layer. Some examples of the digitized banklines in Jamuna River reach starting from Jamalpur up to Manikganj districts have been illustrated in the figures below (**Figure 2** and **Figure 3**):

Figure 2: Banklines in 2001

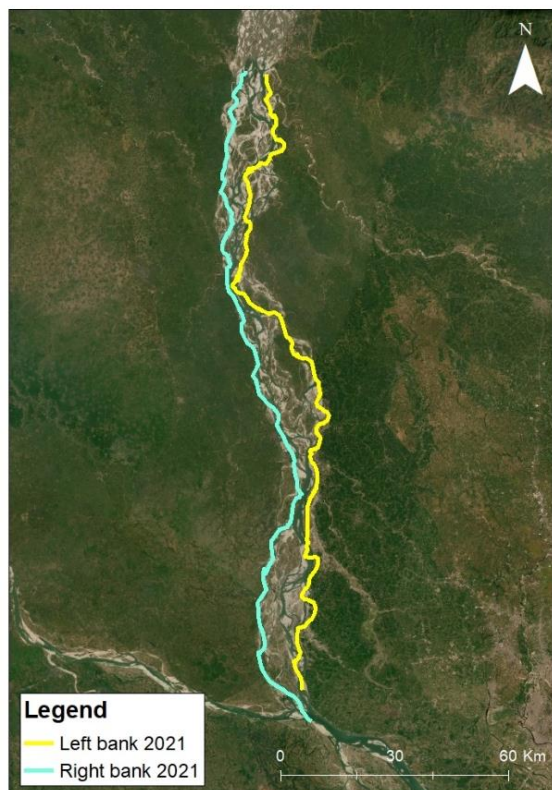
Banklines Digitized from Satellite Image of 2021

Figure 3: Banklines in 2021

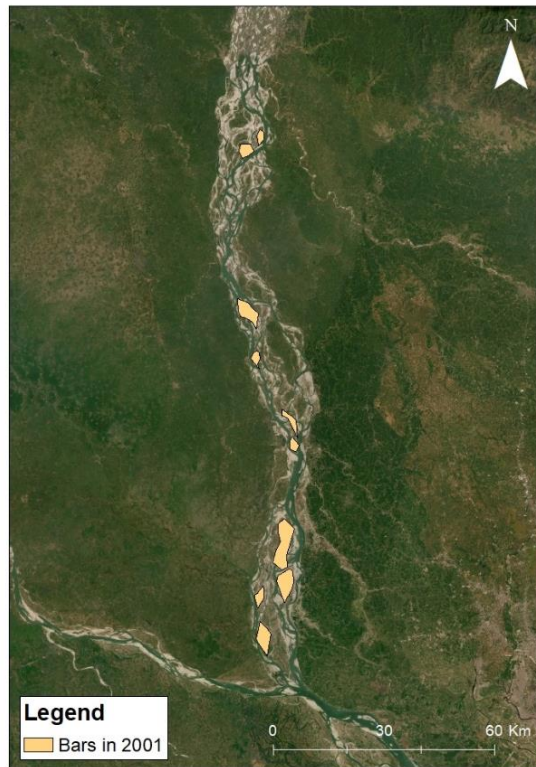
Bars Digitized from Satellite Image of 2001

Similarly, some examples of the digitized bar areas in Jamuna River reach starting from Jamalpur up to Manikganj districts have been illustrated in the figures below (**Figure 4** and **Figure 5**):

Figure 4: Bars in 2001

The analysis also revealed that the bar area of the Jamuna River at this reach grew significantly between 2001 and 2021, expanding from 161.02 km² to 661.91 km², or nearly four times, during that time. In 2001, the bars covered roughly 7.80% of the study area; in 2021, they covered roughly 32.08%. This

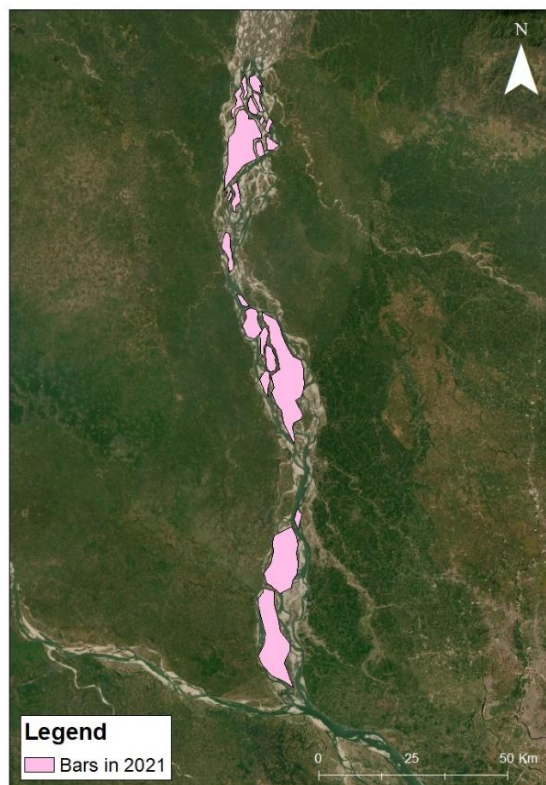
Bars Digitized from Satellite Image of 2021

Figure 5: Bars in 2021
